## **Tree Survey and Arboricultural Constraints**

### **ST FILLANS**

### **ST FILLANS COMMUNITY COUNCIL**

28 February 2022

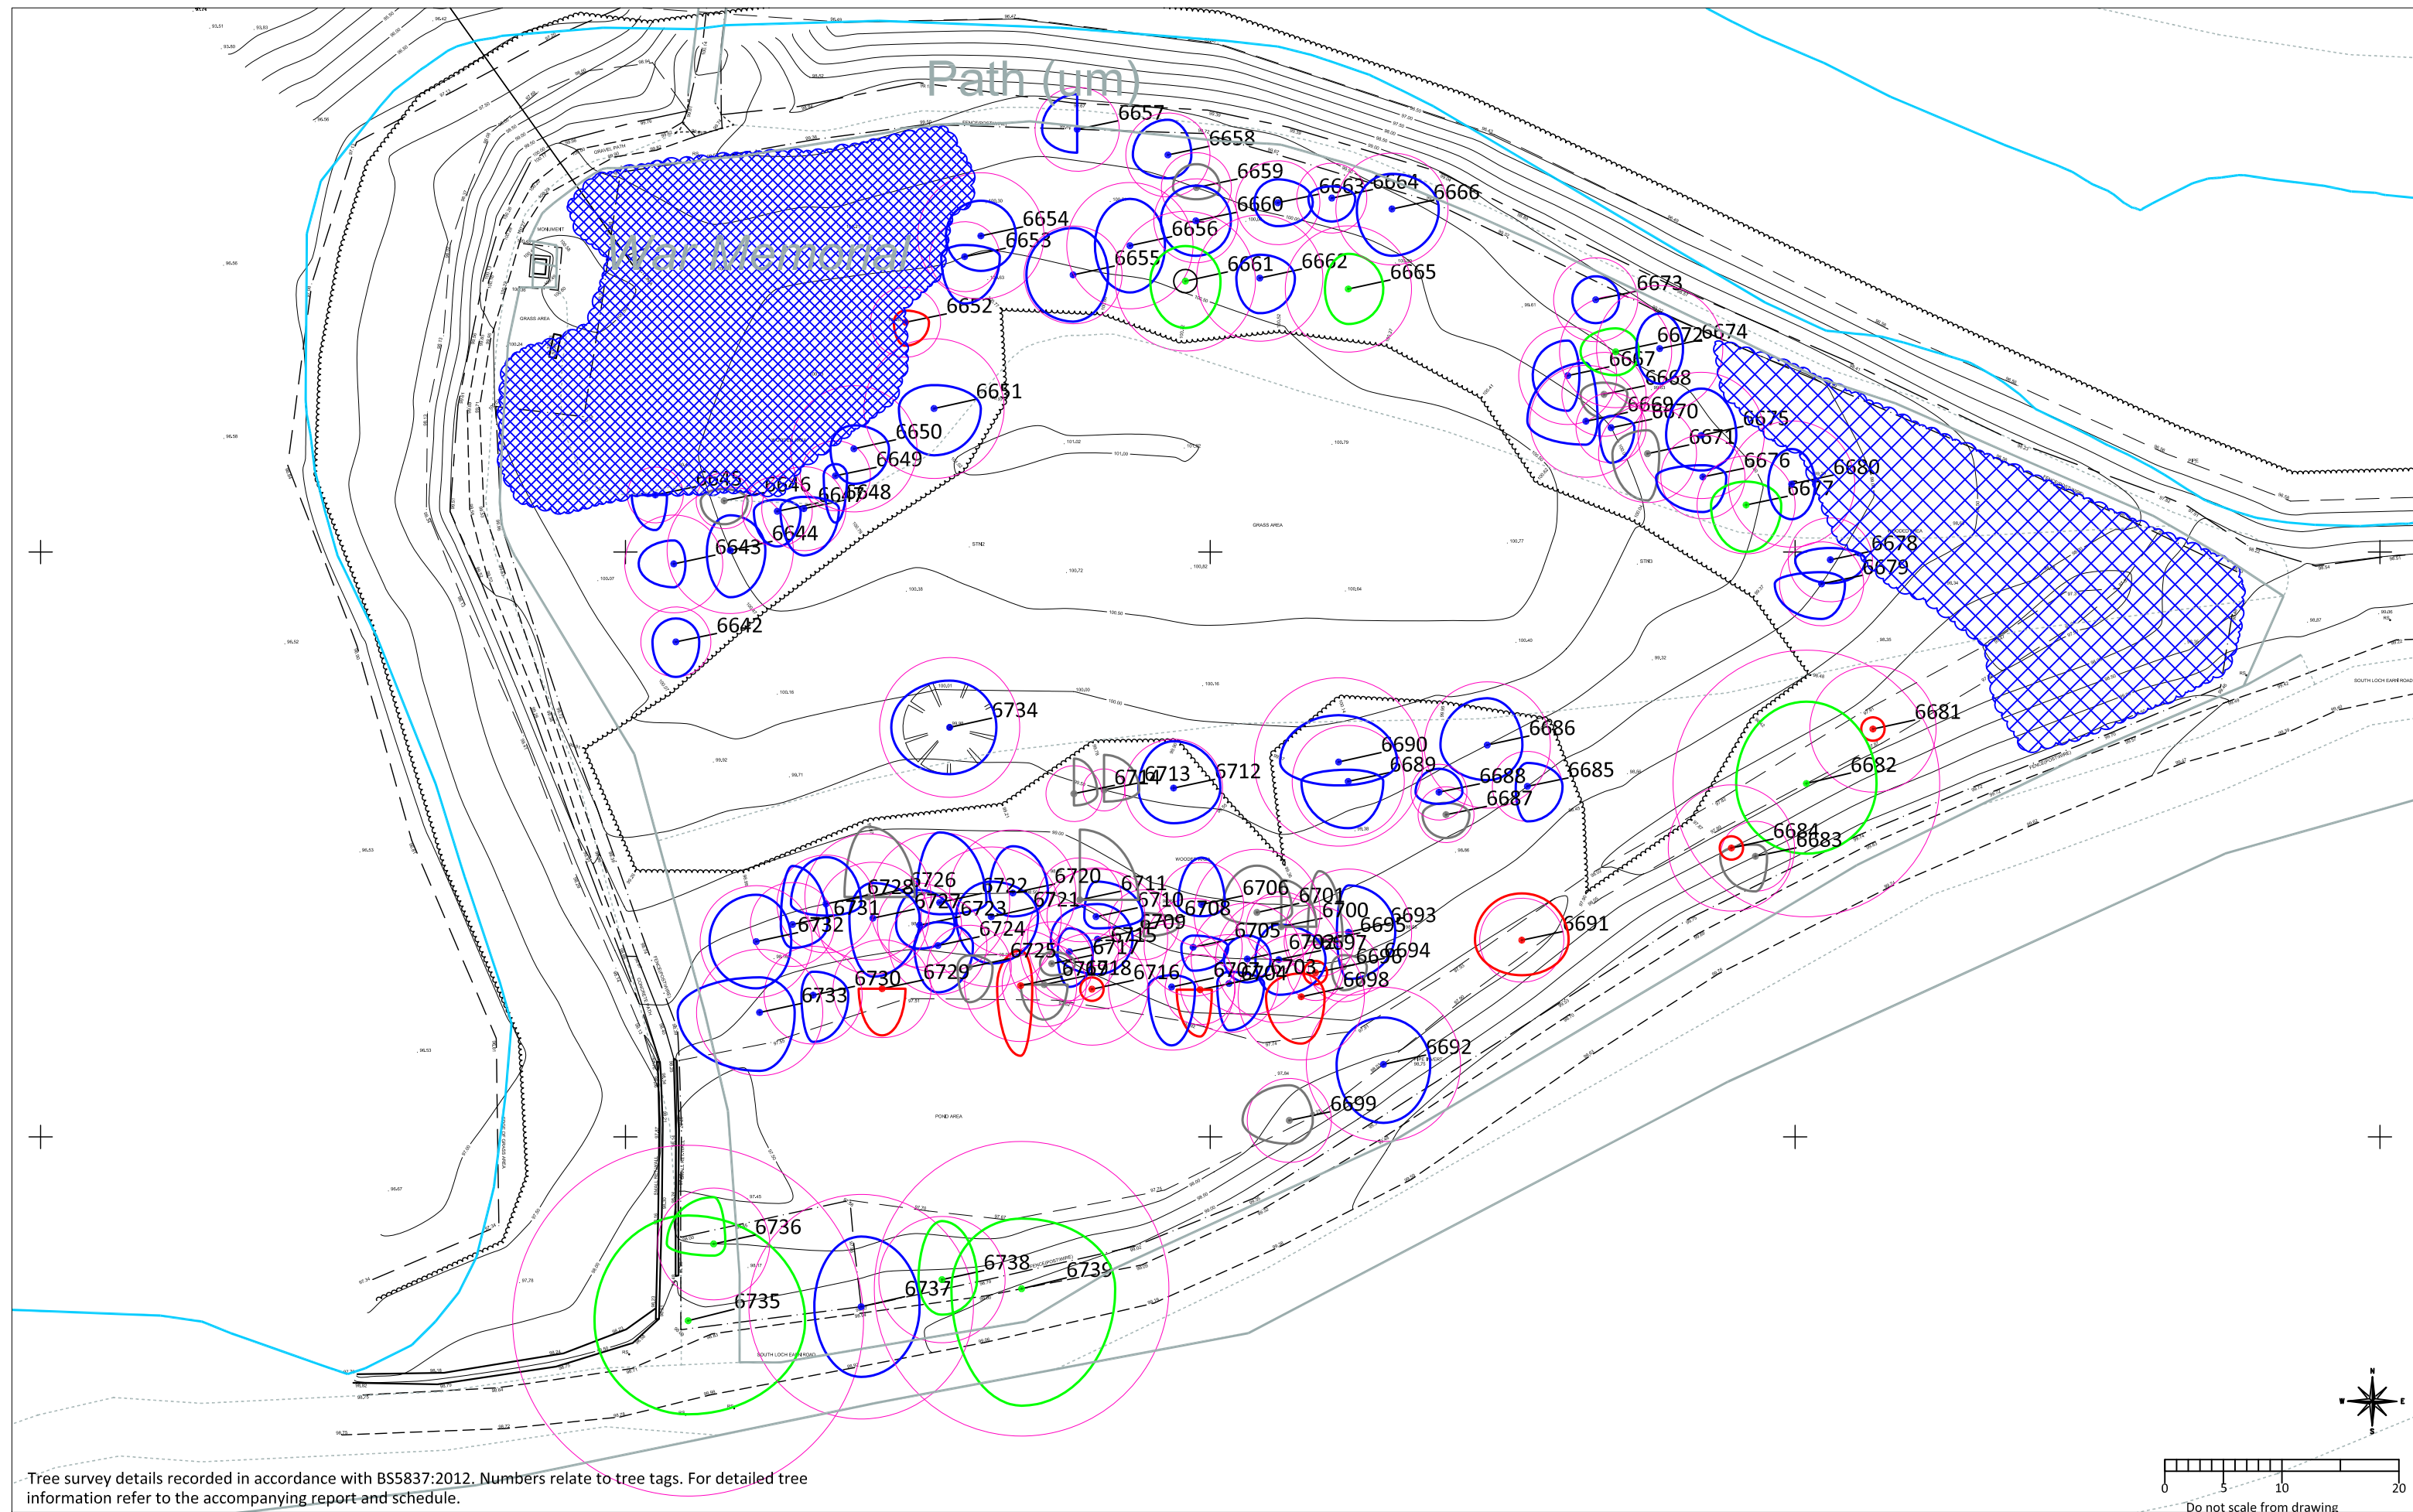
| Tree Survey Plan – Existing..... | 15 |

Tree survey details recorded in accordance with BS5837:2012. Numbers relate to tree tags. For detailed tree information refer to the accompanying report and schedule.
