Archaeological Desk-Based  
Assessment and Walkover Survey  
New Village Hall  
Saint Fillans  
Perth and Kinross

CM09

**ARCHAEOLOGICAL  
DESK-BASED ASSESSMENT AND  
WALKOVER SURVEY  
NEW VILLAGE HALL, SAINT FILLANS  
PERTH AND KINROSS**

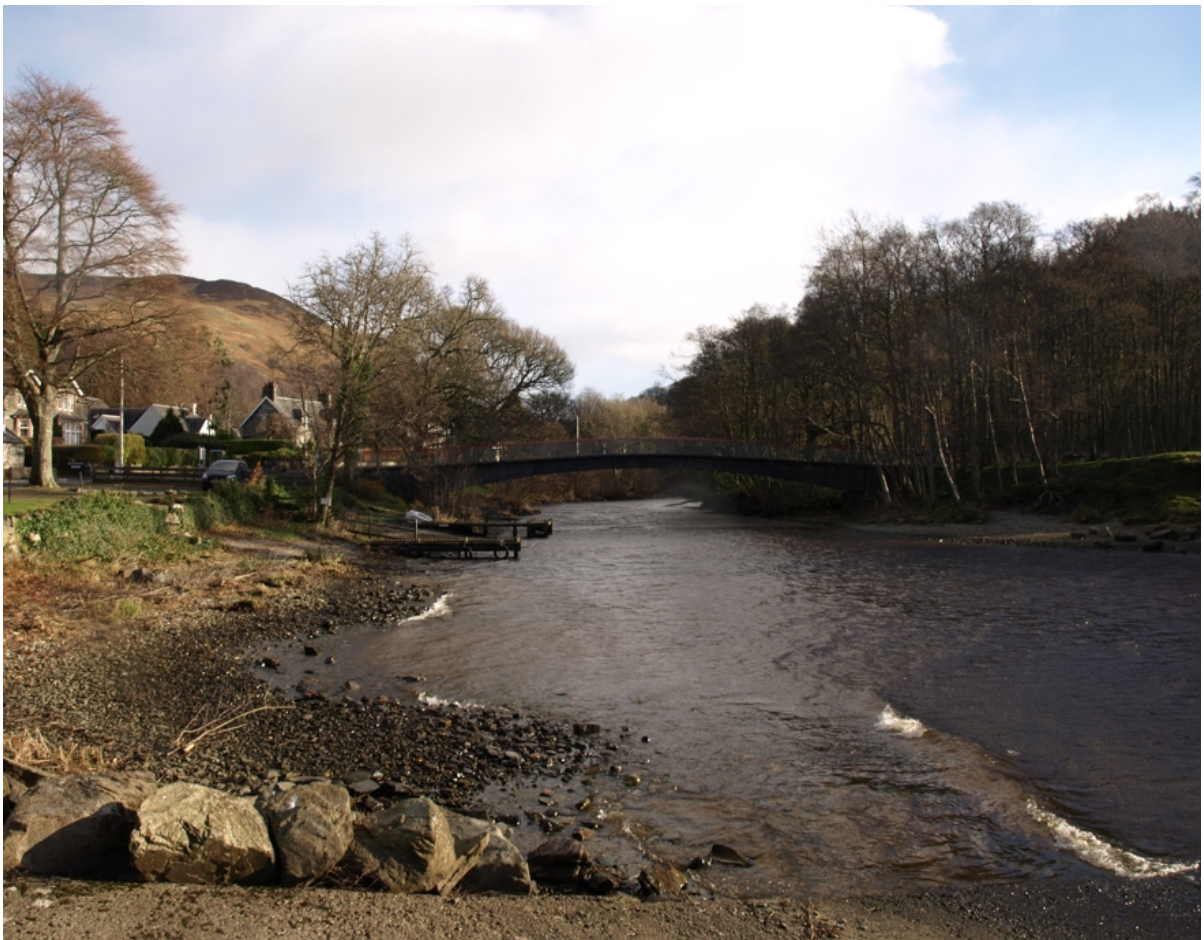
Footbridge 2 over River Earn to site.  
*For Saint Fillans Community Council*

The footpath (1) which encircles the site is still an unobtrusive and recognisable feature. The original footbridge (2) which appears on the Ordnance Survey First Edition (1867) has been replaced in the late 20th century with a rather graceful and delicate single-span reinforced concrete arch bridge, high enough to clear any floodwaters, but low enough to be easily walkable without stairs, and avoid visual intrusion on the landscape. It is of course of no antiquity at all, but it does define the interface of an important loch and river, and its supple curve evokes in a subdued way the more exuberant 'stone rainbows' of some of General Wade's bridges.

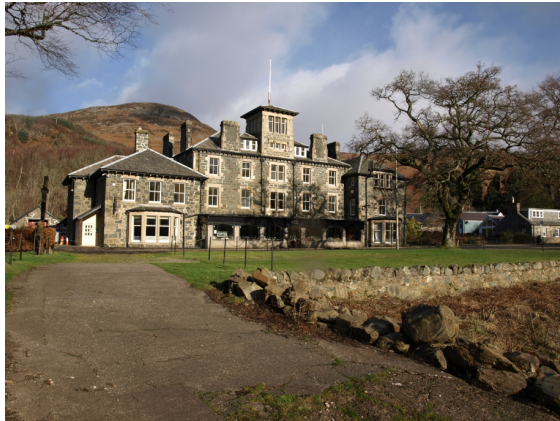
Illustration 3: Loch Earn Hotel 5.

In the village, the nearest listed building to the site is the Hotel (5). This is a substantial and imposing building, an impressive testament to the scale and ambition of the Victorian Highland tourist industry on which the village was built. It defines and dominates the main street of the village, and is clearly visible from the War Memorial and the Footbridge, but from the centre of the site it is practically invisible due to the screen of woodland along the river bank. It is likely that any modest-sized building in the centre of the site will similarly be practically invisible from the Hotel.

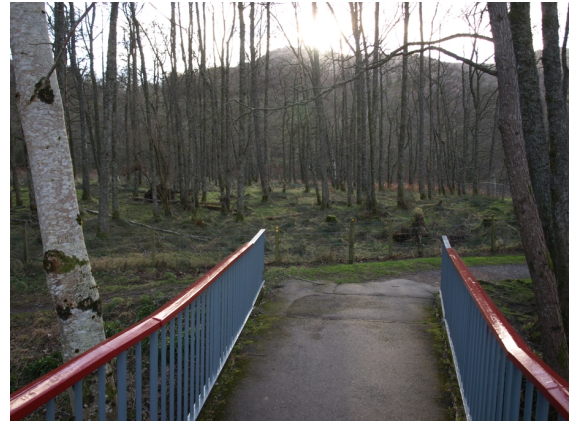
Illustration 6: Site screened by trees.

The development site consists of gently rising ground in the centre, encircled on all sides by a belt of woodland. The central area, where the proposed building, car parks and access tracks will be, is currently open ground, covered with long grass and sedge. This was walked over carefully, but showed no obvious signs of earthworks, structures or other artificial features.

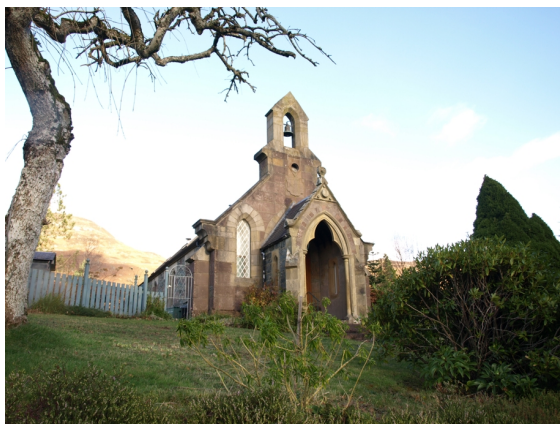
Illustration 4: Former Episcopal Church 4.

The second nearest listed building is the former Episcopal Church (4). This is a very small vernacular gothic building, standing on moderately high ground, set back from the main street, towards the E end of the village. Although it is quite close to the centre of the development site, it is only sporadically visible through gaps between the trees, and then only in mid-winter conditions. Similarly, a modest-sized building in the centre of the site will be barely visible from the church.

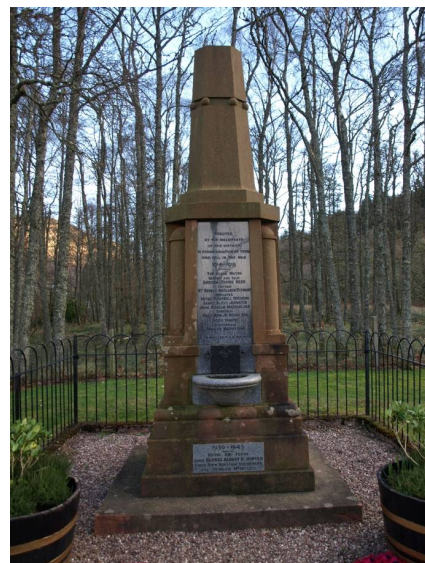
Illustration 7: War Memorial 3. Site beyond, screened by trees.

The War Memorial (3) stands at the W end of the site, on the low bluff overlooking the loch. It is of modest size and simple, unimposing design, as befits a small village. It is easily visible from the village, but does not in any way dominate the

view, being partly overshadowed and screened by the woodland belt behind and partly around it. Its slightly elevated, W-facing position gives impressive views out over the loch, and captures the best of the afternoon and evening sun, creating an exceptionally suitable place for remembrance and reflection. To the E, the Memorial is largely screened from the centre of the development by the belt of woodland encircling the site.

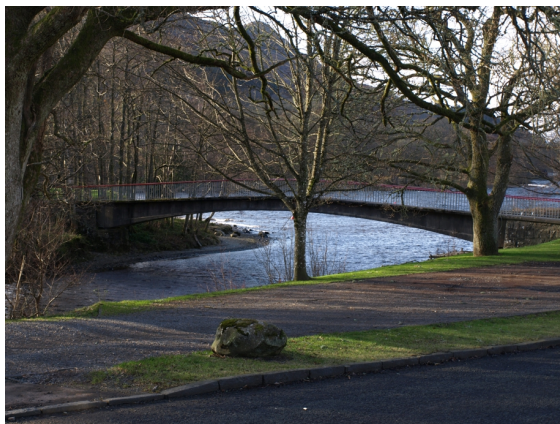
Illustration 5: Footbridge 2 over Earn..

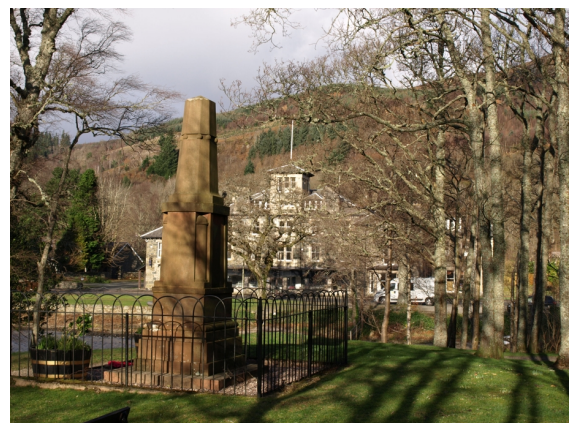
Illustration 8: War Memorial 3, Hotel 5 and village. Site to R, beyond trees.

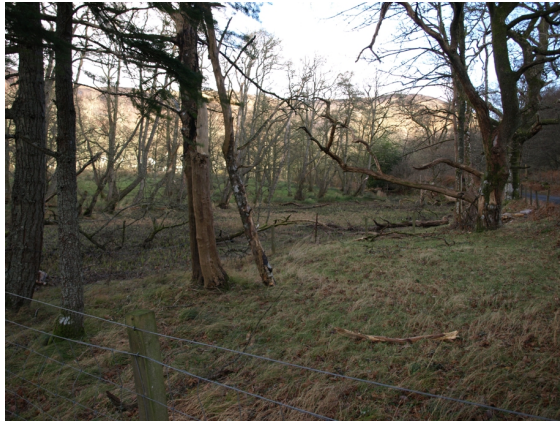
Illustration 9: Channel 7 on S side of site.

On the S side of the development site, the channel (7) which runs roughly parallel with South Loch Earn Road appears to be natural. It is much overgrown, and generally rather damp. A very small rise in the level of the loch would soon flood it, re-connect it to the river and re-establish the site's traditional status as An t-Eilean, 'The Island'.

The channel (7) along the S side of the site appears to be a natural rather than a cultural heritage feature, and is already very irregular in form. It will need to be bridged to provide vehicle access, and perhaps also in places for parking areas. However, if possible it should not be entirely infilled and obliterated, as it defines the 'island' character of the site.

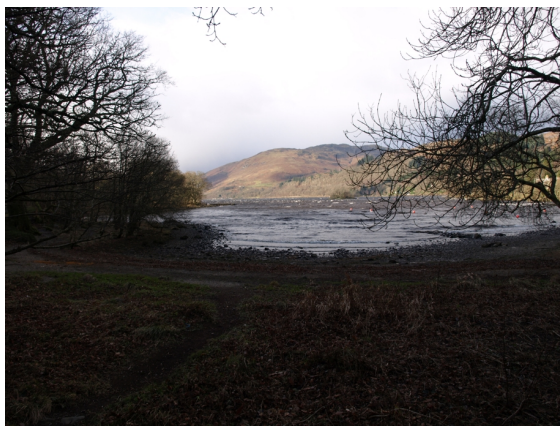
Illustration 10: Entrance of channel 7 from loch.

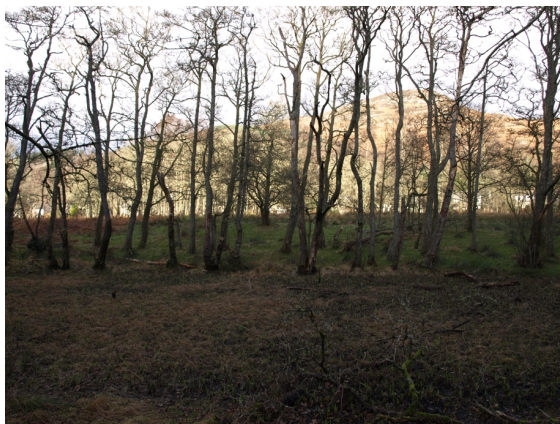
Illustration 11: Centre of site screened N and S by trees..

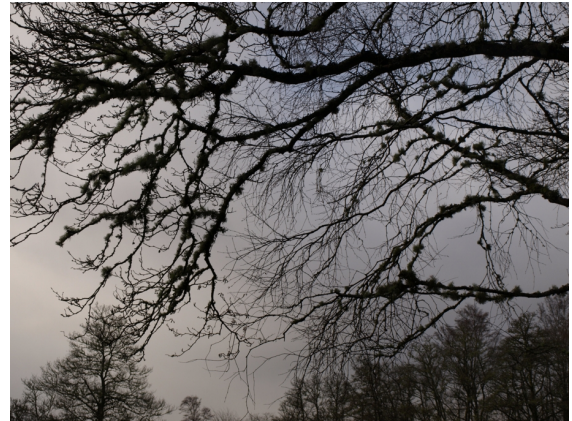
Illustration 12: 'Cloud Forest' moss and lichen, fed by spray from loch.

The surrounding woodland consists mostly of closely spaced, moderately tall but rather spindly birch, alder and similar broadleaves, all deeply gnarled and twisted, and profusely overgrown with moss and lichen. Their appearance is very reminiscent of the well-known 'cloud forest' seen in parts of Kintyre and Knapdale. The prevailing westerly winds are funnelled by the surrounding high mountains into a sort of wind-tunnel, over the loch, and then out over the development site, which lies exactly at the only eastern exit from the loch. In windy conditions a constant fine spray is whipped off the surface of the loch to feed the mosses and lichens on the trees. The close spacing of the tree trunks, and the depth of the belt of woodland make a more or less impenetrable visual screen between the centre of the site and the village and surrounding area, even in winter when the leaf canopy is entirely missing.

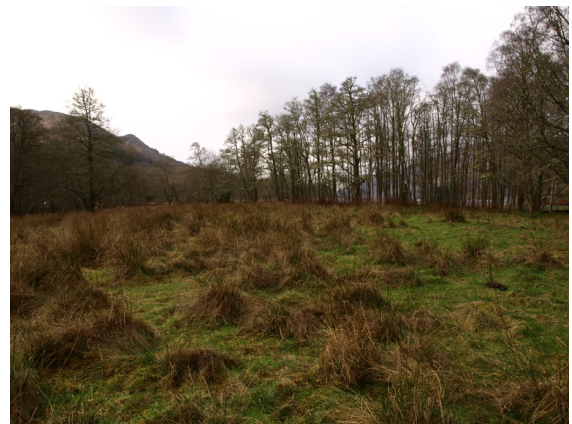
Illustration 13: Raised centre of site, screened by trees all round. War Memorial 3 hidden beyond trees.

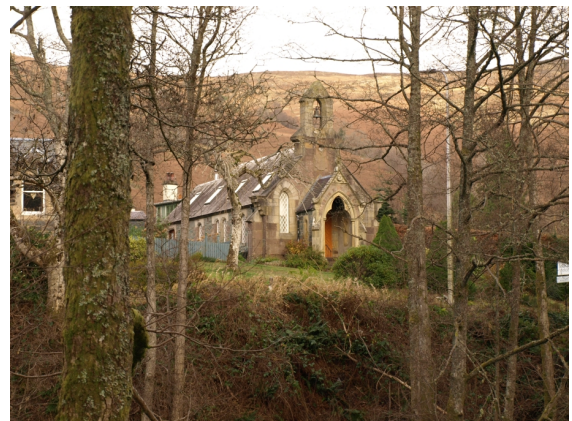
Illustration 14: Former Episcopal Church 4 beyond screen of trees.

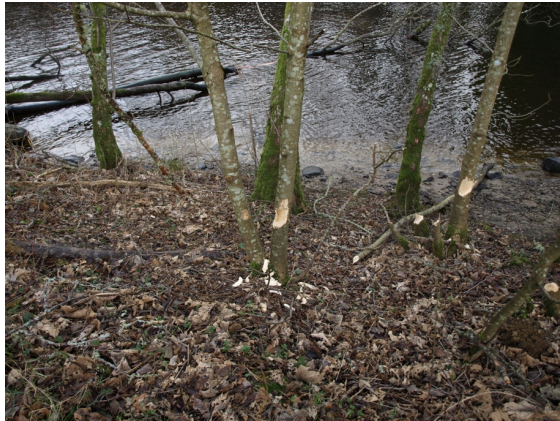
Illustration 15: Trees on river bank, gnawed by beavers.

Perhaps well-adapted to the site's micro-climate, the Earn's recently resettled beaver population are evidently making themselves at home, with gnawed stumps and branches along the N perimeter of the site, on the bank of the river.

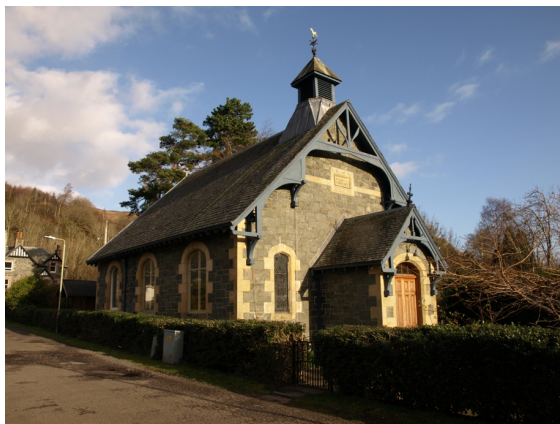
Illustration 16: Dundurn Parish Church 6, from Manse Lane.

The farthest listed building in the study area is Dundurn Parish Church (6). The church is set well back from the street frontage, and the main road bends away to the NW before it reaches the church. As a result, as well as being screened by the trees on the development site, the site is completely invisible from the church, and practically so even from the church gate on the street frontage.
